EVALUATION OF HIGH STRENGTH COLUMBIUM ALLOYS FOR ALKALI METAL CONTAINMENT

FINAL REPORT

Covering the Period
July 25, 1962 to December 15, 1964

prepared for
NATIONAL AERONAUTICS AND SPACE ADMINISTRATION
CONTRACT NAS 3-2140

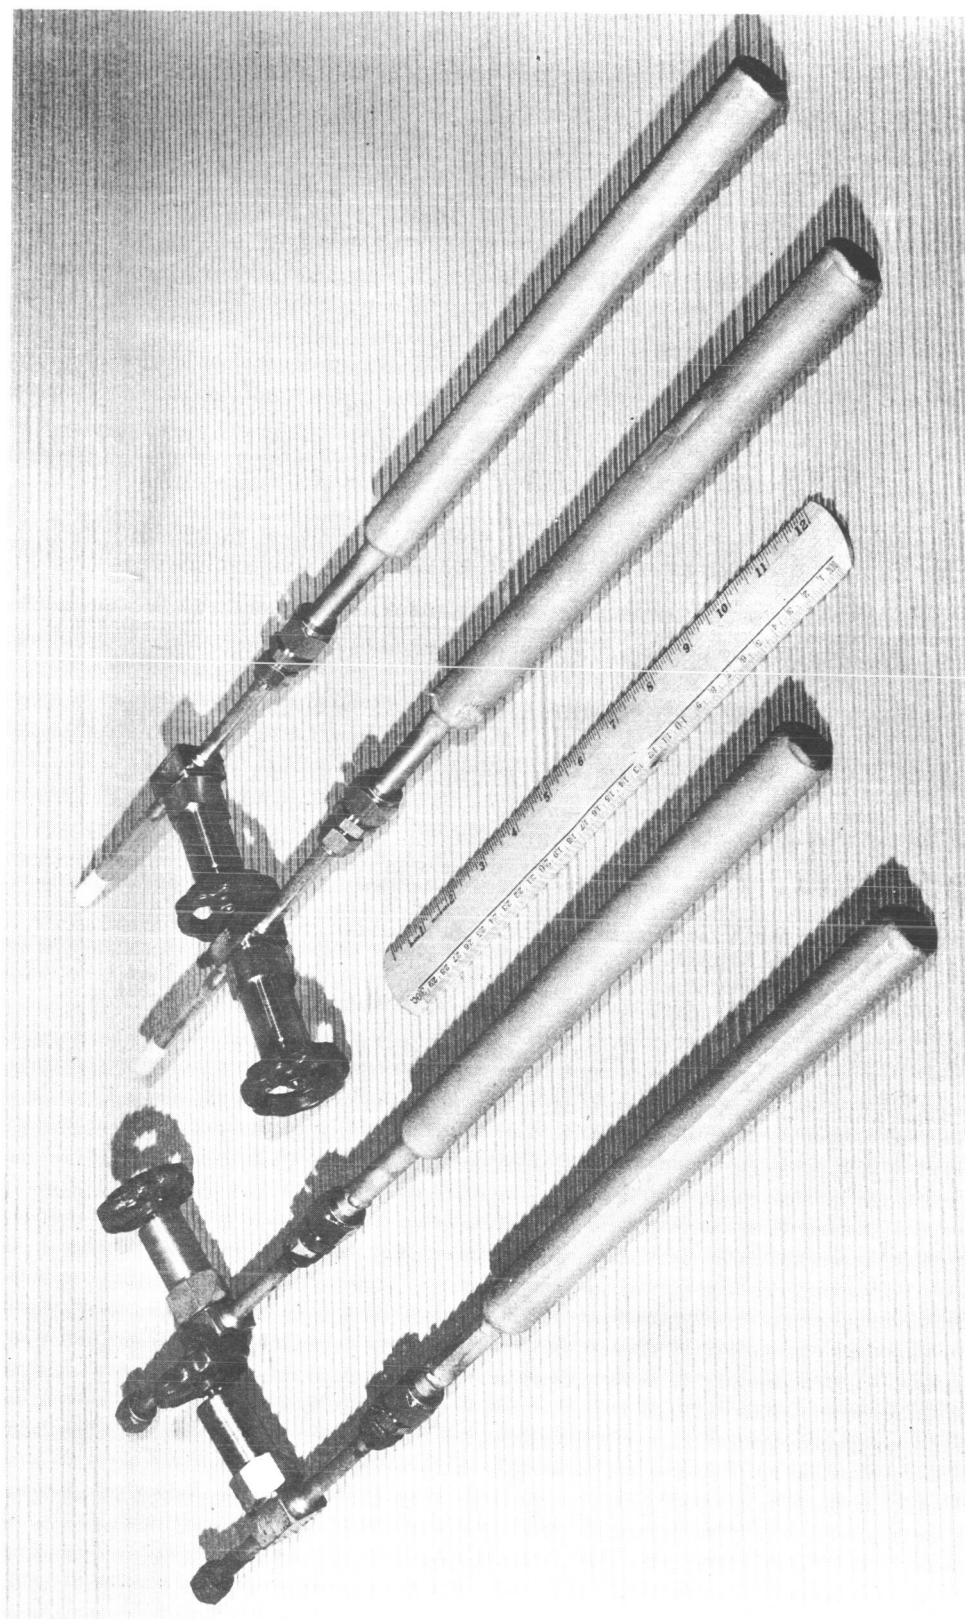
Figure 4. AS-55 Alloy Capsules Nos. 8 and 9 (left) and Cb-1Zr Alloy Capsules Nos. 6 and 7 (right) Prior to Filling with Potassium.

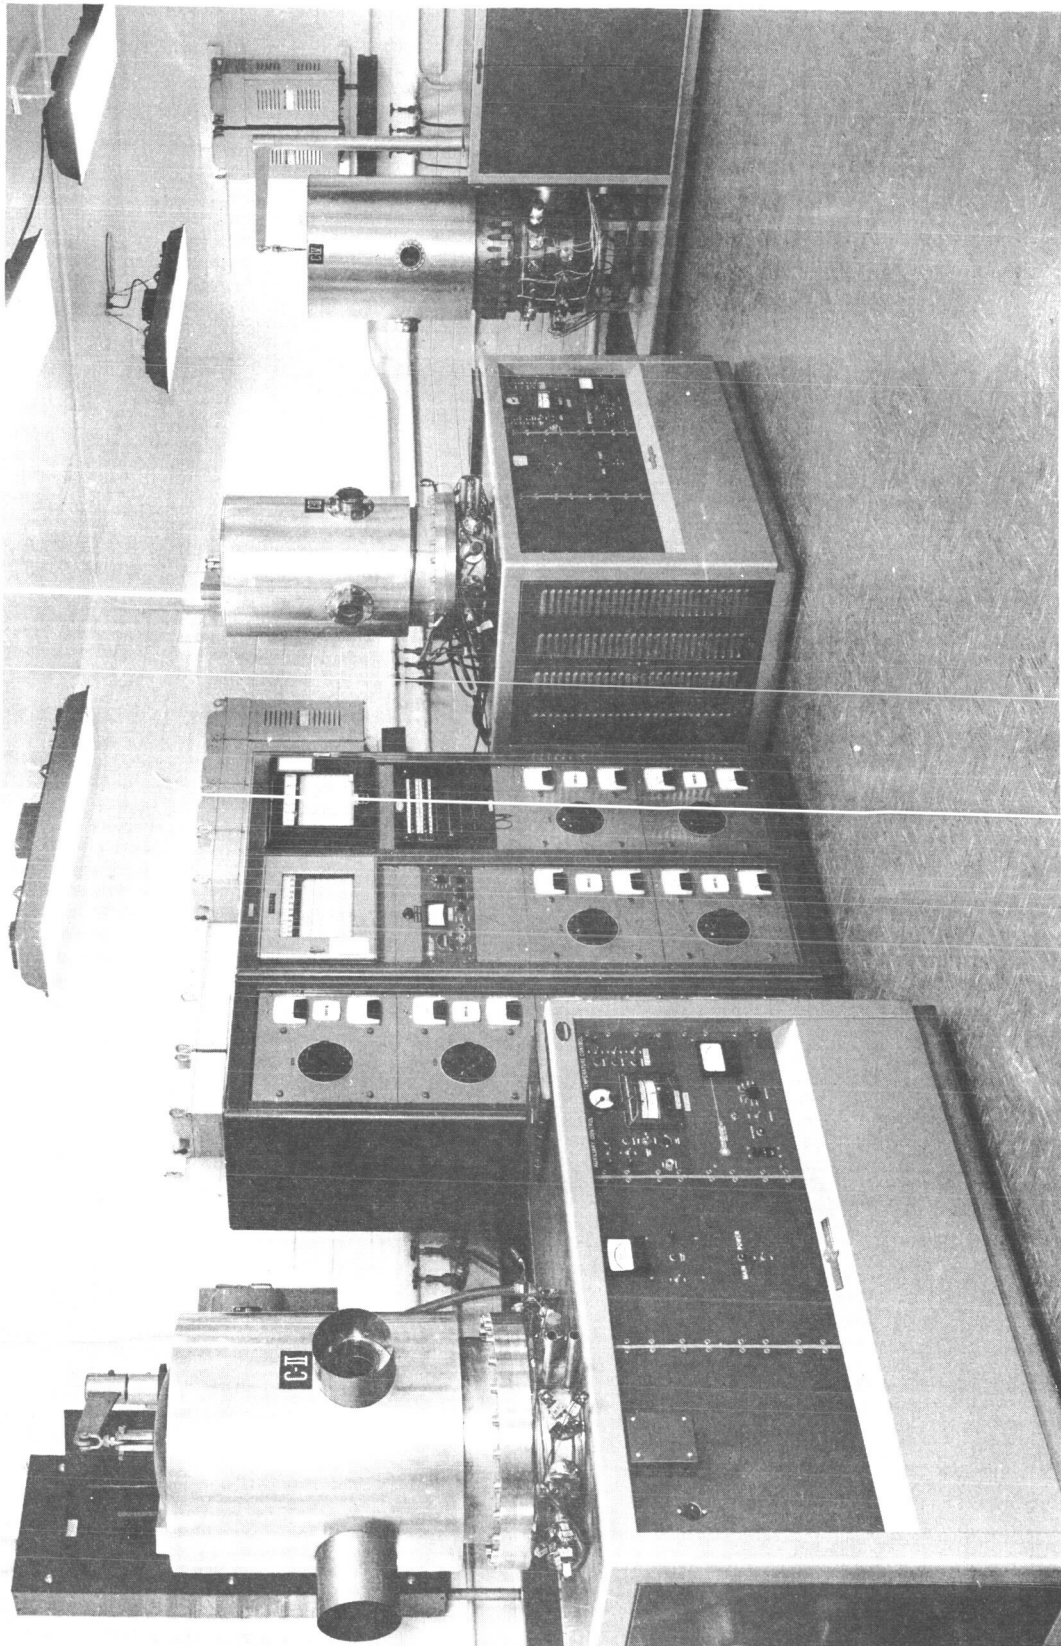
Figure 10. Varian Ultra-High Vacuum Systems Used for Capsule Corrosion Tests; Units Equipped with 400 and 1000 l/Sec Getter-Ion Pumps.

Reflux capsules No 11 and No. 12 (AS-55 alloy) and No. 2 and No. 4 (D-43 alloy) were installed in the Varian ultra-high vacuum chamber C-II, which is similar to chamber C-III, and instrumented in the same manner as capsules No. 6, No. 7, No. 8, and No. 9. The chamber was evacuated to a pressure of 5.0×10^{-7} torr, as measured by a Bayard-Alpert type ionization gauge attached to the side of the chamber. During heat-up to the test temperature of 2000°F , the pressure reached

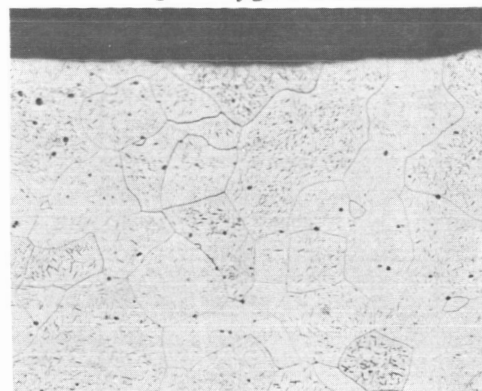
(A370411)

AS-55 Alloy Capsule No. 9
High Oxygen Potassium

Figure 27. Microstructures of AS-55, D-43, and Cb-1Zr Alloy to Potassium at 2000°F in a Vacuum of 10^{-9} Torr.

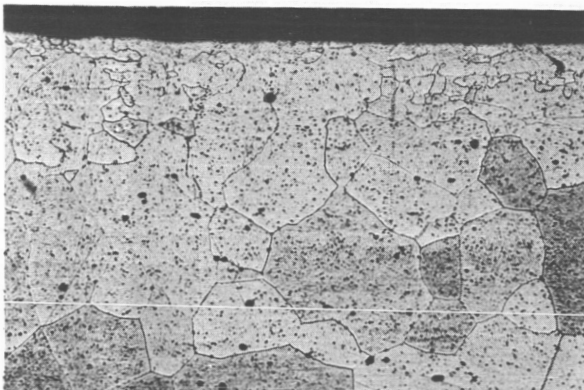
(A070511)

Figure 28. Microstructure of Welds in AS-55, D-43, and Cb-1Zr Alloy Capsules After Exposure to Potassium at 2000°F in a Vacuum of 10⁻⁶ Torr. Etchant: 60% Glycerine, 20% HNO₃, 20% HF

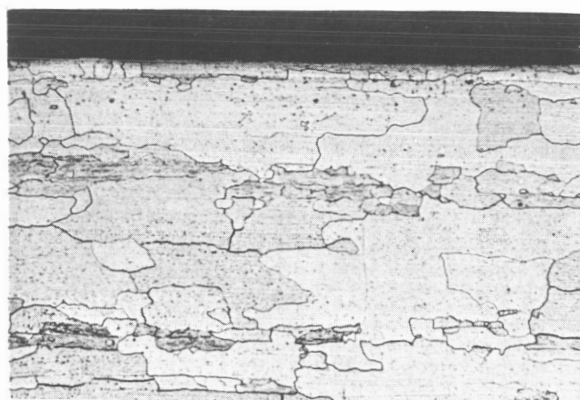
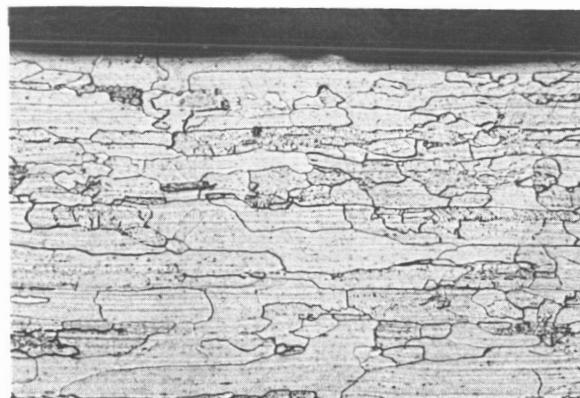
(A390211)

Reflux Corrosion Capsules Before and After 10,000-Hr Exposure

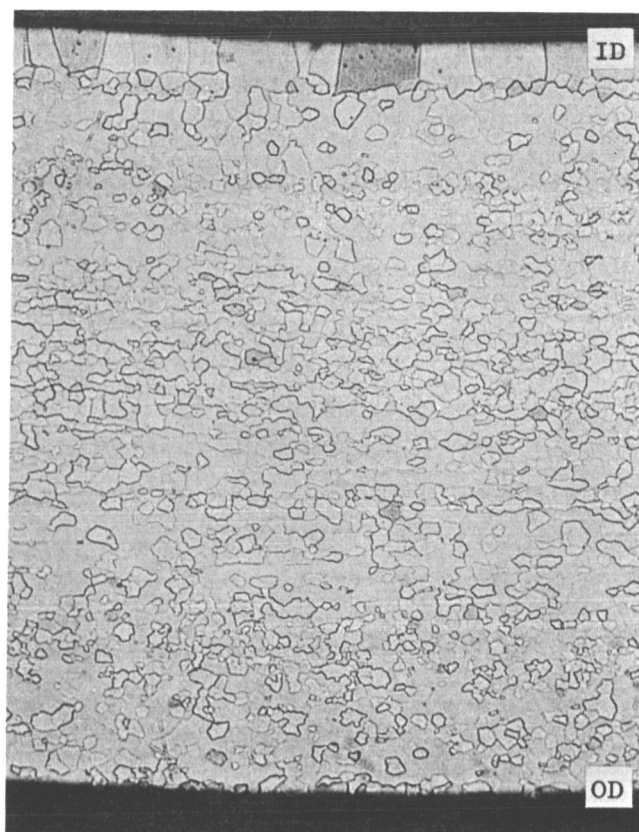
(A350112)

Figure 30. Microstructure in Condensing Zone of Cb-1Zr Alloy Reflux Corrosion Capsule No. 7 After 10,000-Hr Exposure to Potassium at 2000^oF in a Vacuum of 10⁻⁹ Torr.

Relatively large grains observed, after testing, on the inside diameter of Cb-1Zr alloy capsule No. 7 in the condensing zone (Figure 30) are believed to result from accelerated grain growth following the previously discussed loss of oxygen and zirconium from the condensing zone. No grain boundary precipitate was observed near the inside diameter in the condensing zone of Cb-1Zr alloy capsule No. 7; this correlates with an anticipated shift in the $ZrO_2=Zr+2O$ equilibria as the result of the decreasing zirconium and oxygen content in the columbium. This type grain growth was not observed in Cb-1Zr alloy capsule No. 6 tested for 5000 hr.

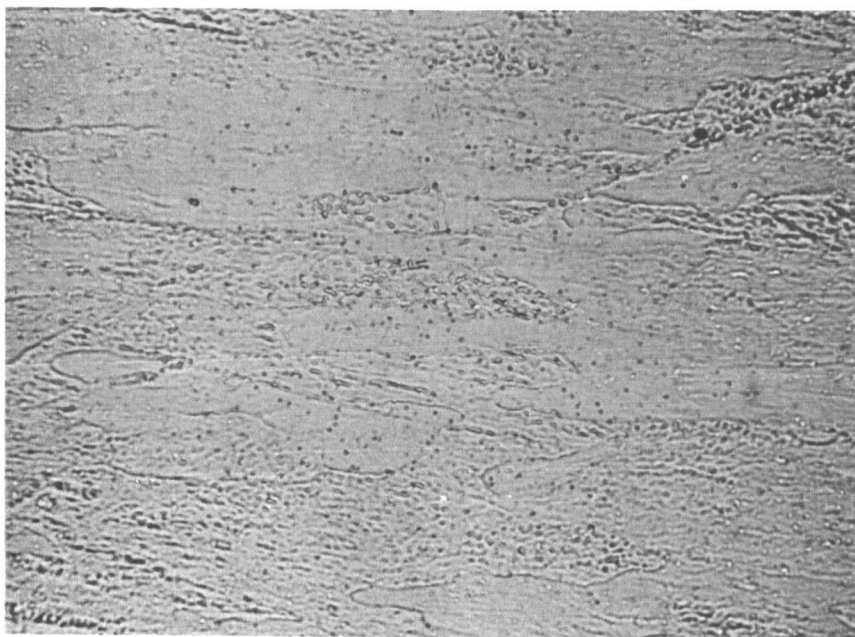
Post Test (A390413)

Figure 32. Microstructure of D-43 Alloy Reflux Corrosion Capsule Before and After 10,000-Hr Exposure to Potassium at 2000^oF in a Vacuum of 10⁻⁹ Torr.

Etchant: Stain Etched

A grain boundary precipitate was observed in D-43 alloy capsule No. 4 after 10,000 hr of testing and, again, was tentatively identified as a columbium-zirconium carbide through stain etching techniques (Figure 32). A re-examination of D-43 alloy capsule No. 2, which was tested for 5000 hr, revealed a similar grain boundary precipitate.
